Waters of the U.S. Survey Summary Report for the Proposed Holden Canyon Connector Road and Decommissioned Road Segments Santa Cruz and Pima Counties, Arizona

TO: 70B01C20F00000993 WA02 and TO: 70B01C22F00001380 WA06

RECON Number 9740-2/10217-6 January 3, 2024

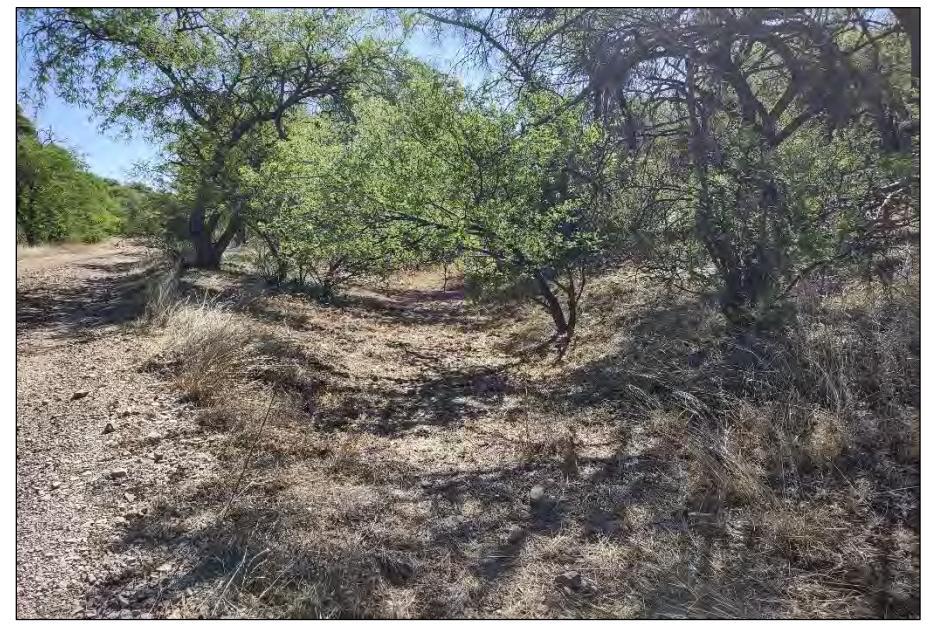
| | | | | | Ordinary H | igh Water Mark | Field Indic | ators | | | | | | | Yes/No | | | |
|---|---|---|--|---|--|--|---|---|---|---|---|---|---|---|---|--|---|--|
| 21 | 31.44738 | -111.34638 | No | Yes | No | No | Yes | No | No | No | R | Mesquite, grass | 2–3 | N/A | No | N/A | 8 | Grassy swale; no upstream or downstream connectivity |

Drainage 21, Photo 1. Looking upstream, facing northeast. No downstream connectivity.

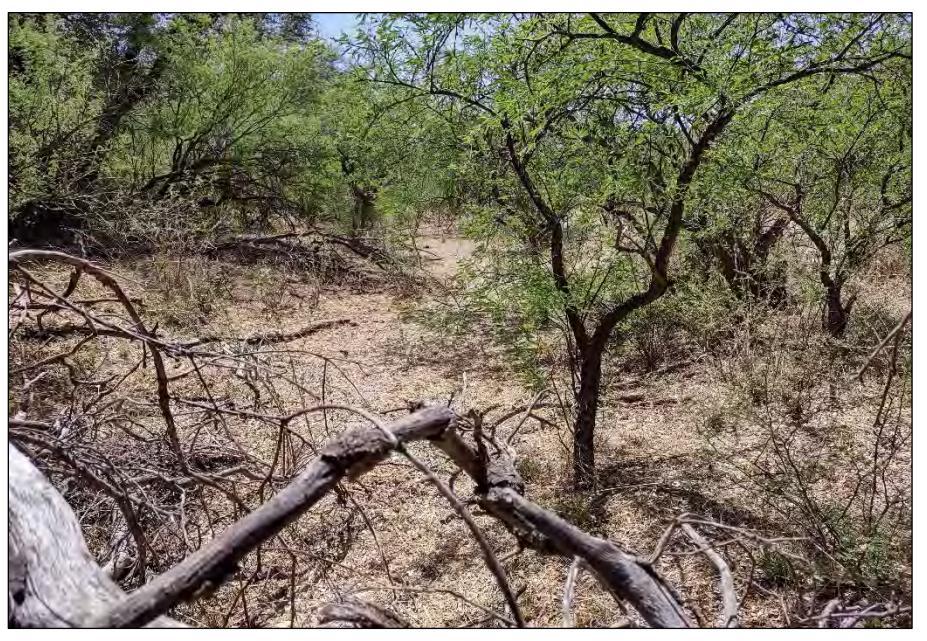
Drainage 21, Photo 2. Looking downstream, facing southwest. Land high on upstream end.

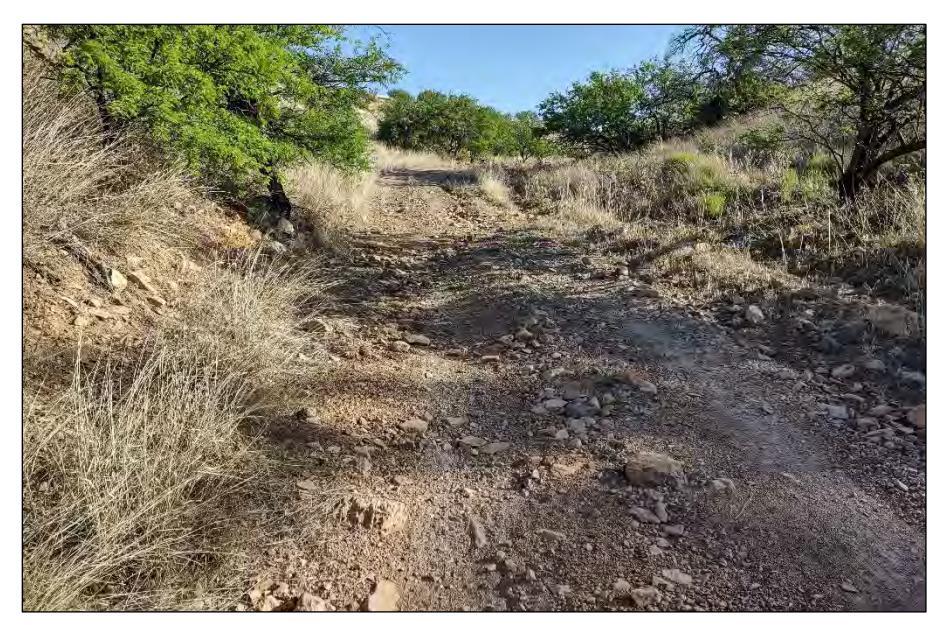
Drainage 28, Photo 5. Looking upstream, facing north at end (no more downstream).

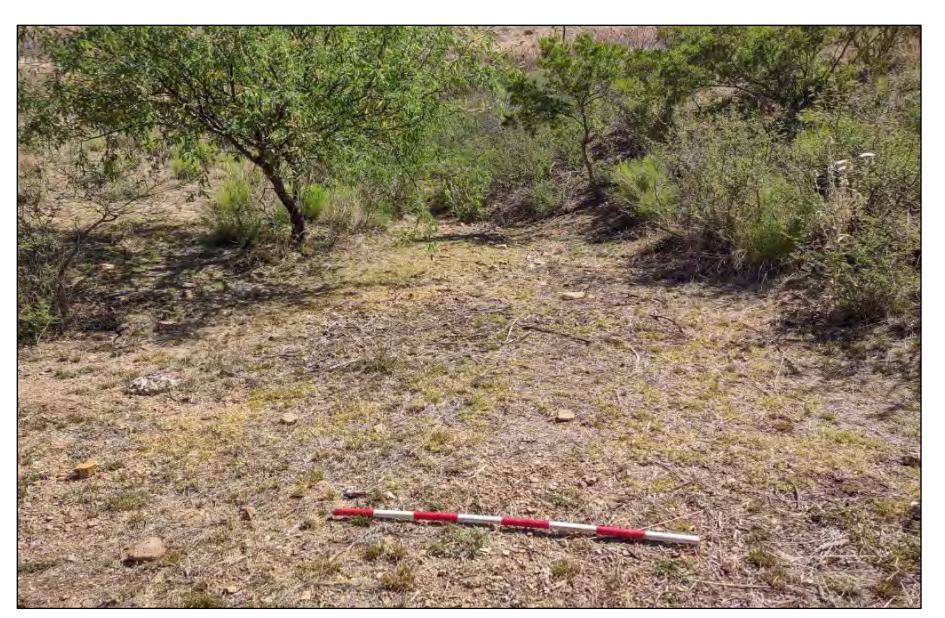
| | | | | | Ordinary Hi | gh Water Mark | Field Indic | ators | | | | | | | Yes/No | | | |
|---|---|---|--|---|--|--|---|---|---|---|---|---|---|---|---|--|---|--|
| 40 | 31.40562 | -111.27819 | Yes | Yes | No | No | No | No | No | No | R | Mesquite, grass Mesquite, grass | 3 | N/A N/A | No | N/A N/A | 19 | Middle has high |

Drainage 40, Photo 1. Looking upstream, facing northeast. High spot in middle.

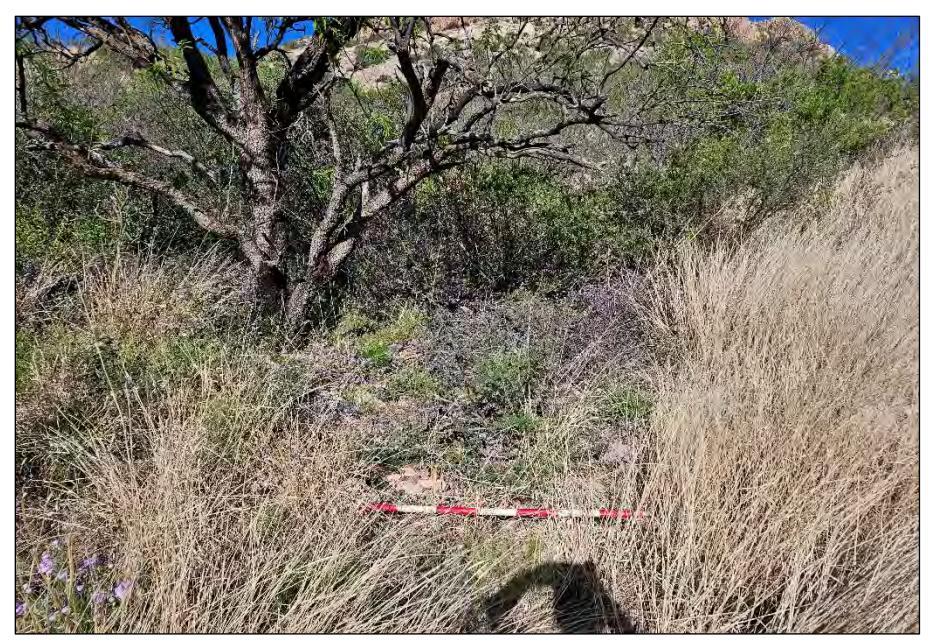
Drainage 44, Photo 1. Looking upstream, facing southwest.

| | | | | | Ordinary Hi | gh Water Mark | Field Indic | ators | | | | | | | Yes/No | | | |
|---|---|---|--|---|--|--|---|---|---|---|---|---|---|---|---|--|---|--|
| 44 | 31.40288 | -111.24300 | Yes | Yes | No | No | Yes | No | No | No | R | Mesquite scrub | <2 | N/A | No | N/A | 23 | Erosional feature |

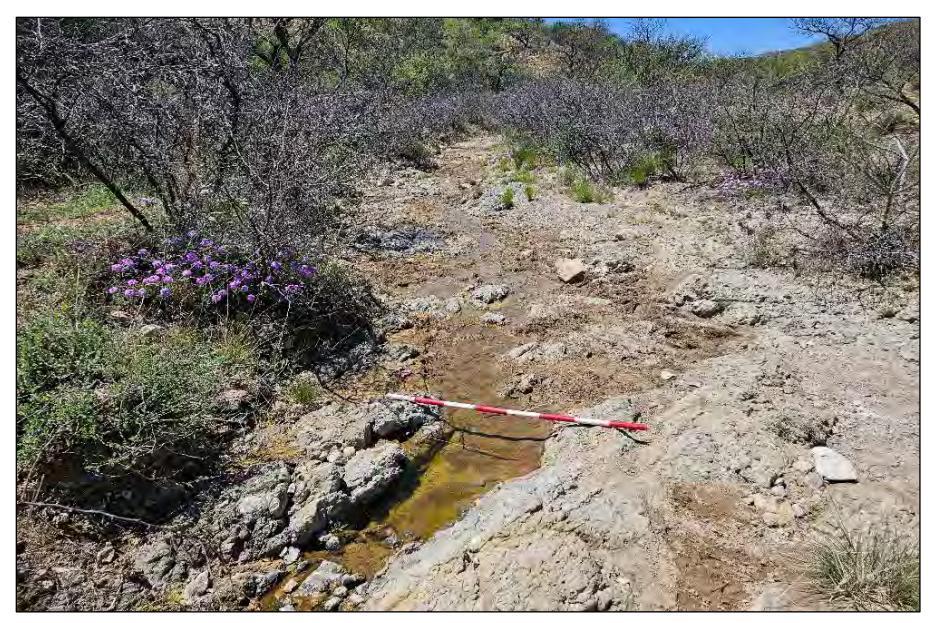
Drainage 49, Photo 2. Looking downstream, facing west-northwest.

| | | | | | Ordinary Hi | gh Water Mark | Field Indic | ators | | | | | | | Yes/No | | | |
|---|---|---|--|---|--|--|---|---|---|---|---|---|---|---|---|--|---|--|
| 49 | 31.38709 | -111.24308 | Yes | Yes | Yes | Yes | Yes | Yes | Yes | Yes | R | Acacia scrub | 5 | 202.95 | Yes | 0.060 | 25 | Bedrock, bugs |
