Appendix E
FEMA Application for a Letter of Map Revision
Niagara County, New York

Application - Letter of Map Revision (LOMR)

Niagara County, New York

Niagara Falls Air Reserve Station

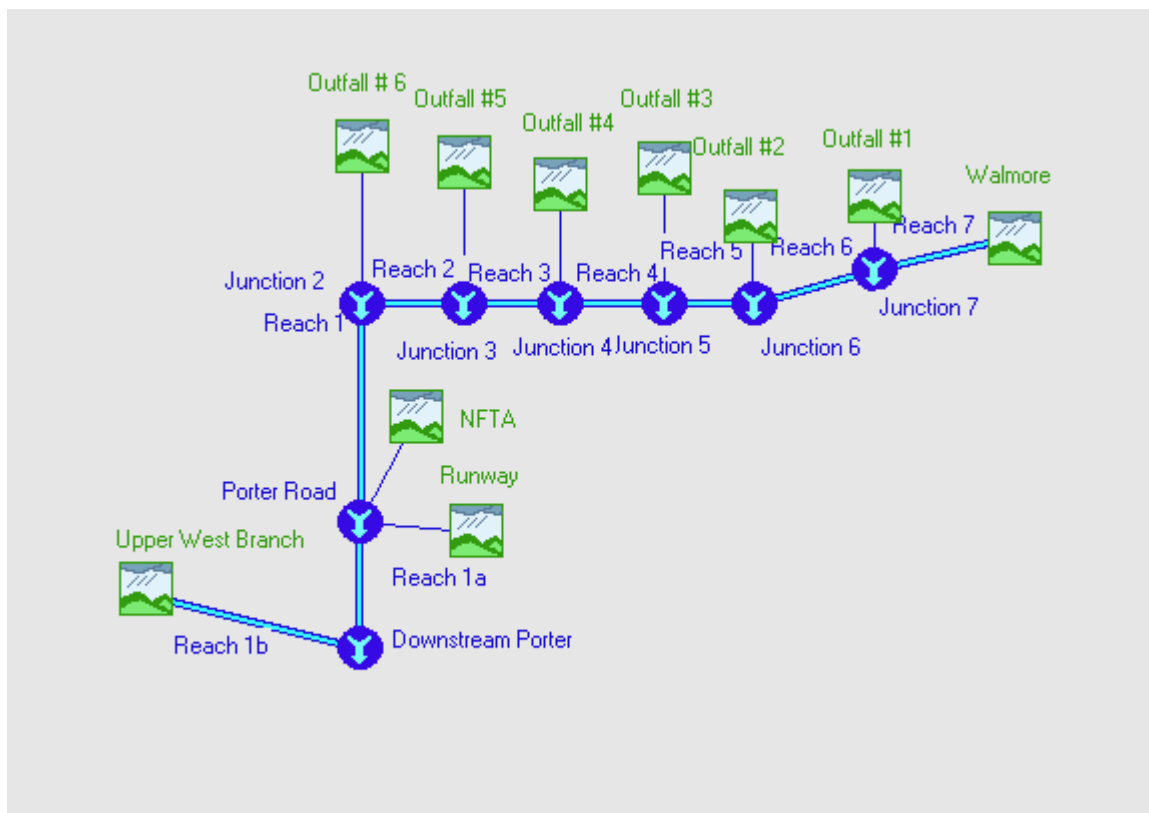
The Niagara Falls Air Reserve Station (air base) occupies 624 acres within the fence line of the air base. The air base has permanent easements on an additional 361 acres, for a total of 985 acres. The Cayuga Creek watershed was broken into 10 sub-basins as shown on following schematic. The air base within the fenced area is presented by 6 of the 10 sub-basins. The total drainage area of these 6 sub-basins is 706 acres. This sum of the drainage areas (of the 6 sub-basins that represent the air base) is greater than the fenced area of the air base because some of the sub-basins drain lands that are outside of the air base. This will account for the difference between the acreage of the fenced areas and the sub-basins. The schematic of the HEC-HMS model is shown below:

Watershed size, rainfall (total and temporal pattern), loss rate parameters, and unit hydrograph parameters are all needed to calculate runoff. The assumptions and methods used to develop these parameters for use in the HEC- HMS computer model are discussed below.

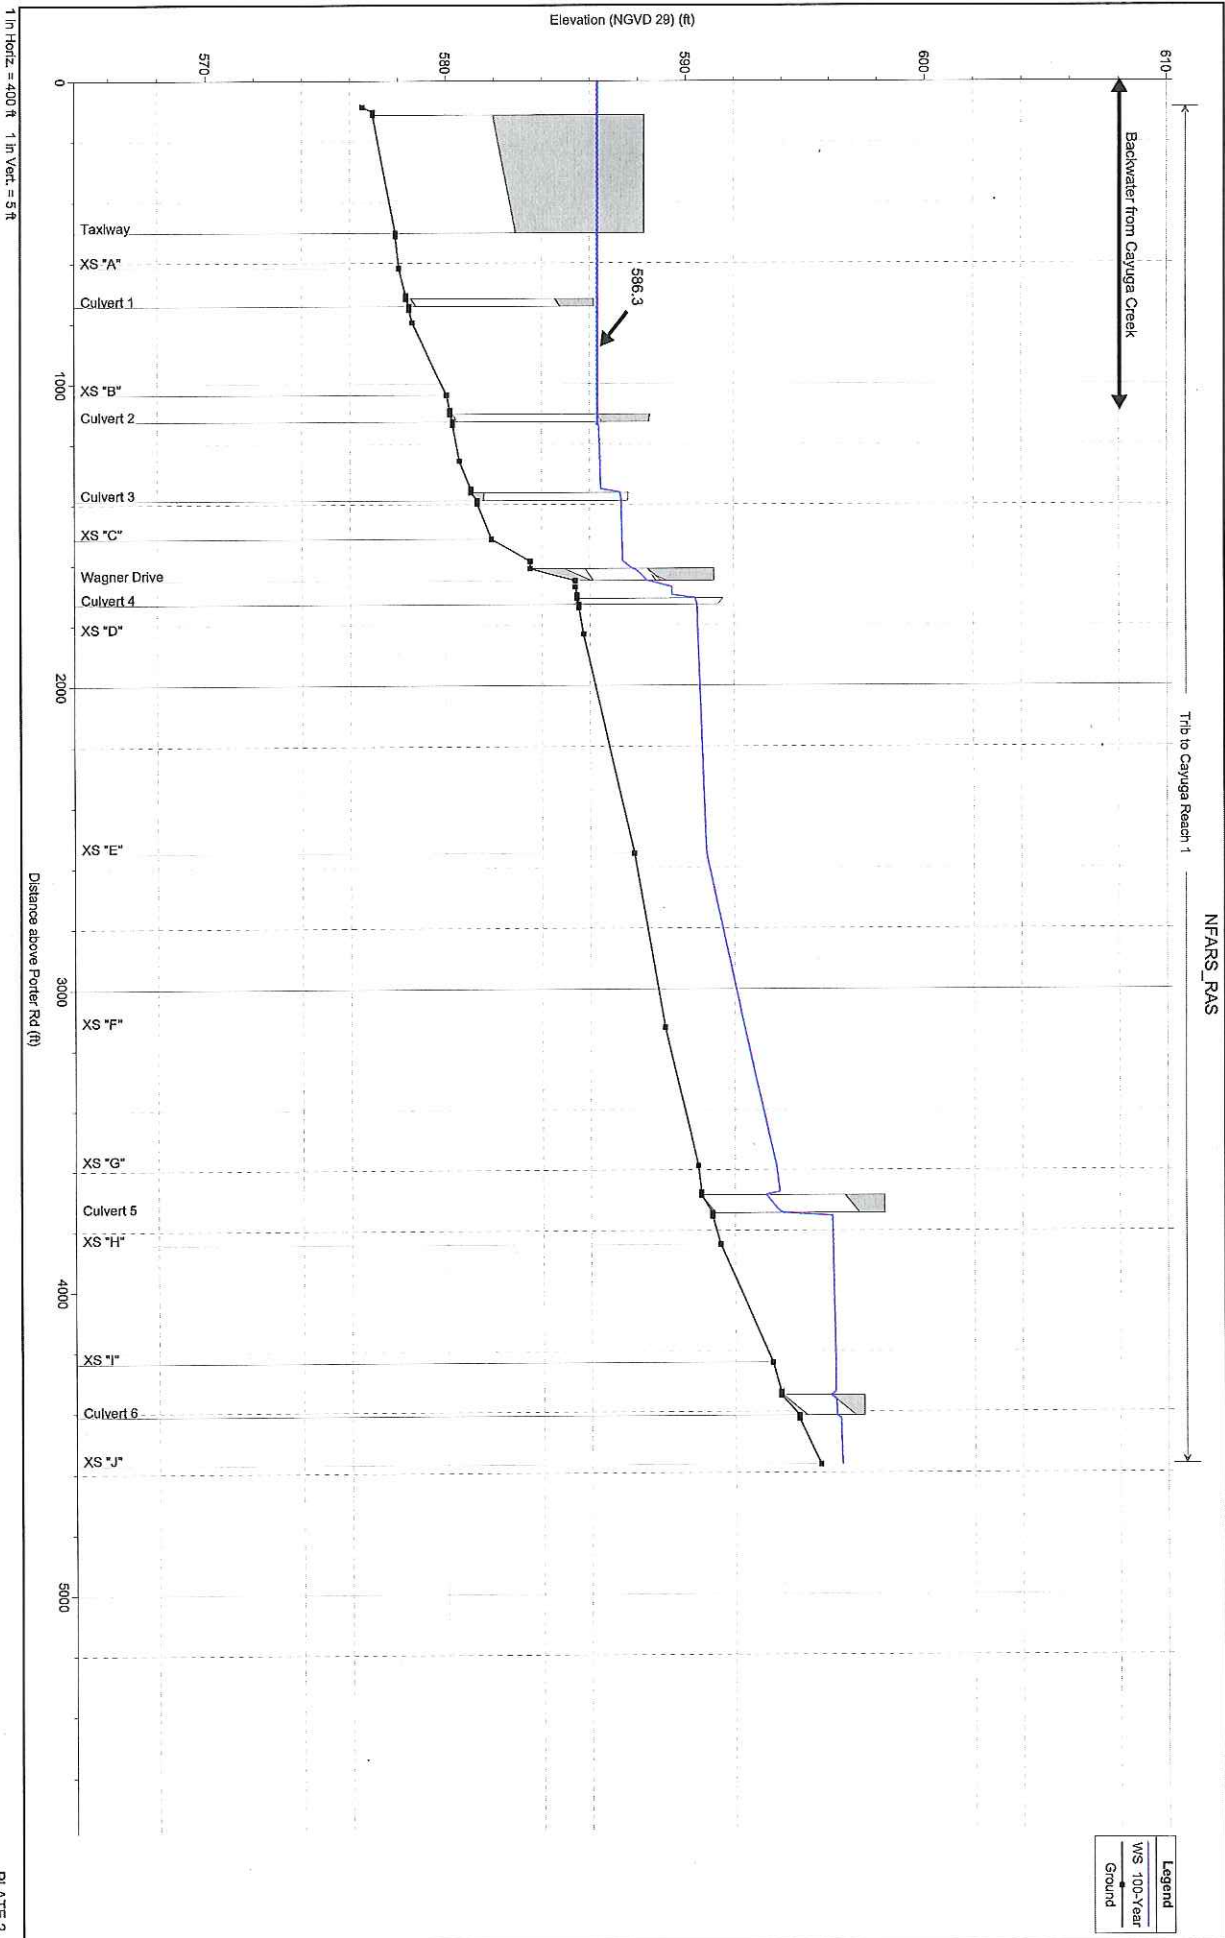
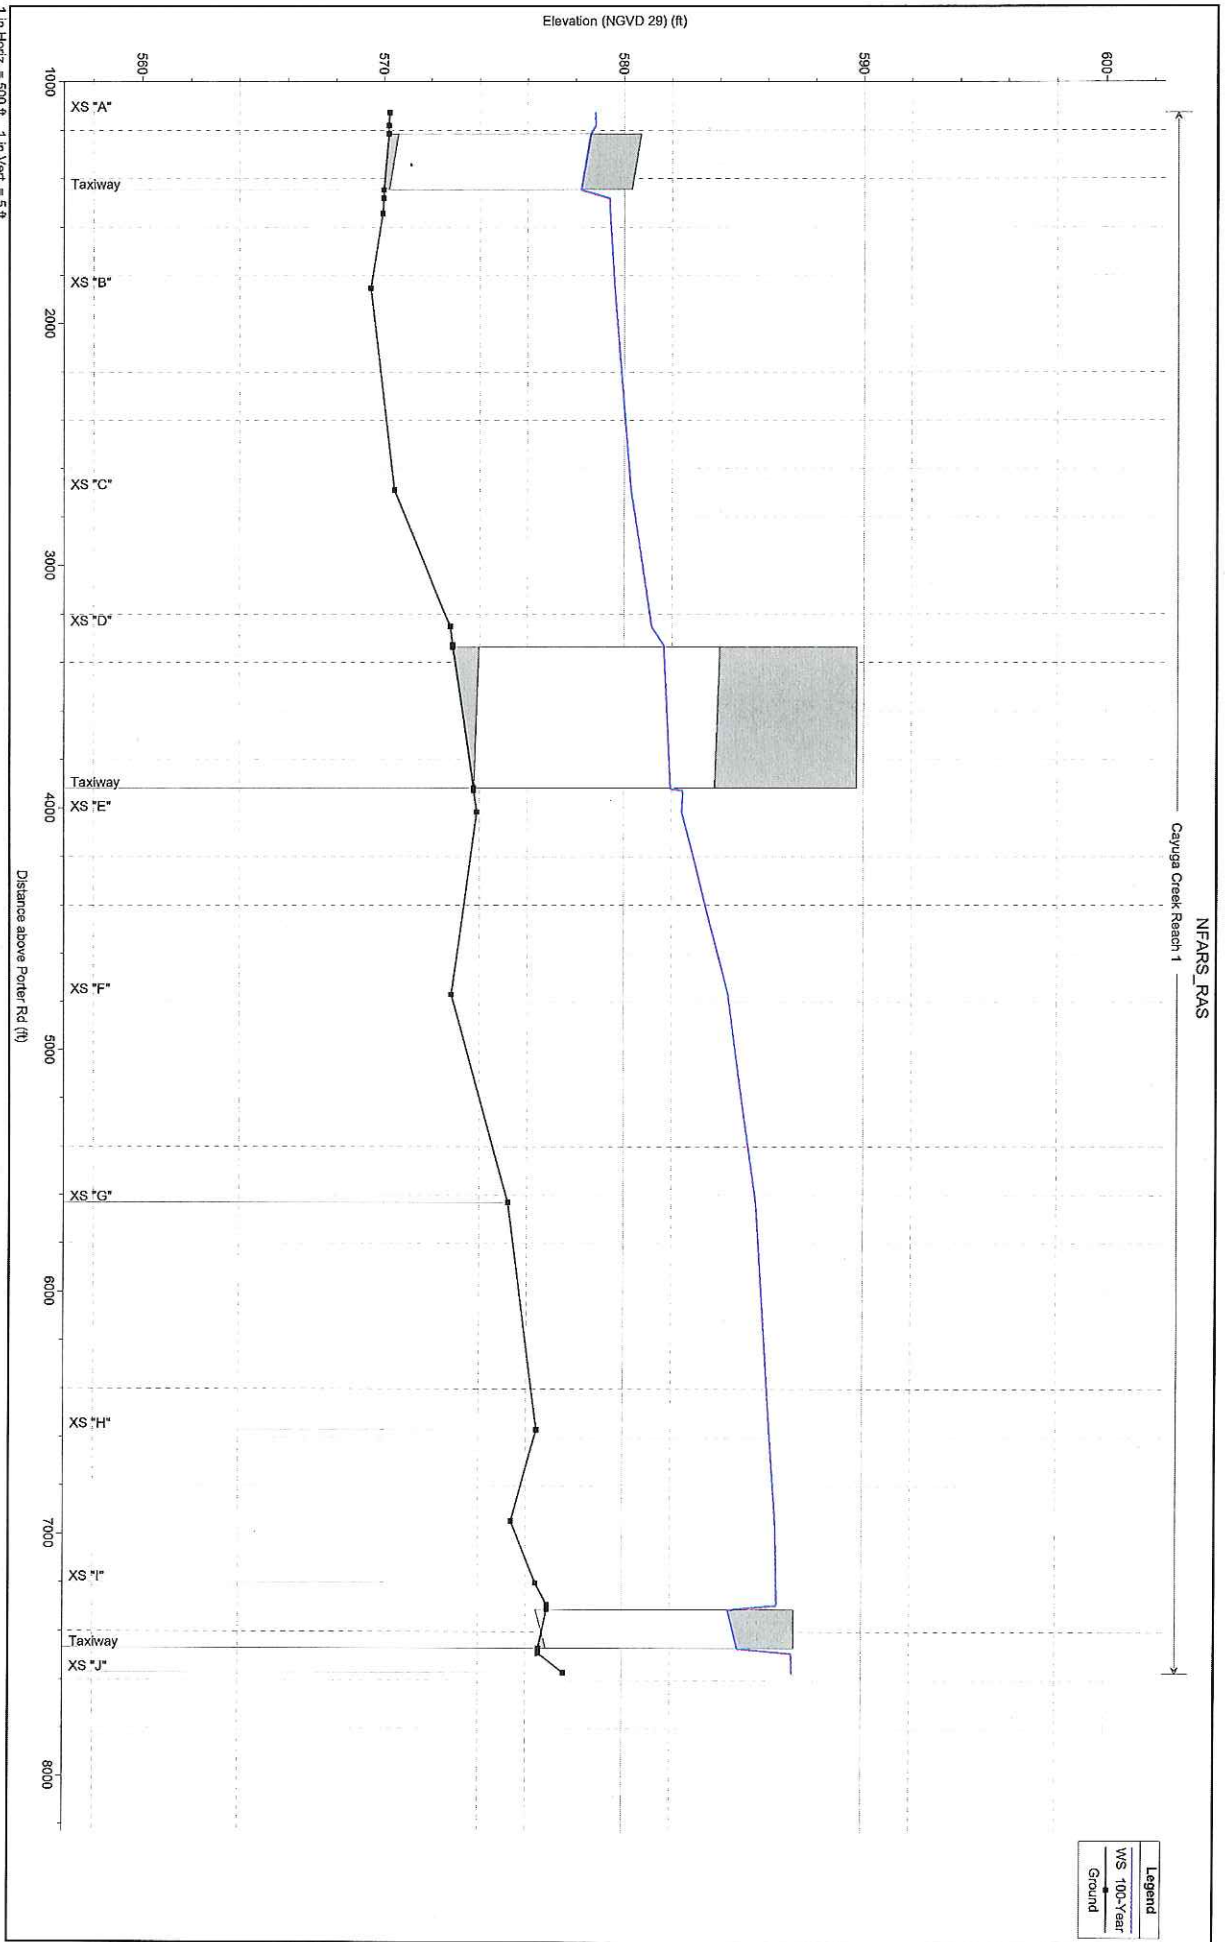
FLOODWAY DATA

**CAYUGA CREEK AND
UNNAMED TRIBUTARY TO CAYUGA CREEK**

1 in Horiz. = 500 ft 1 in Vert. = 5 ft

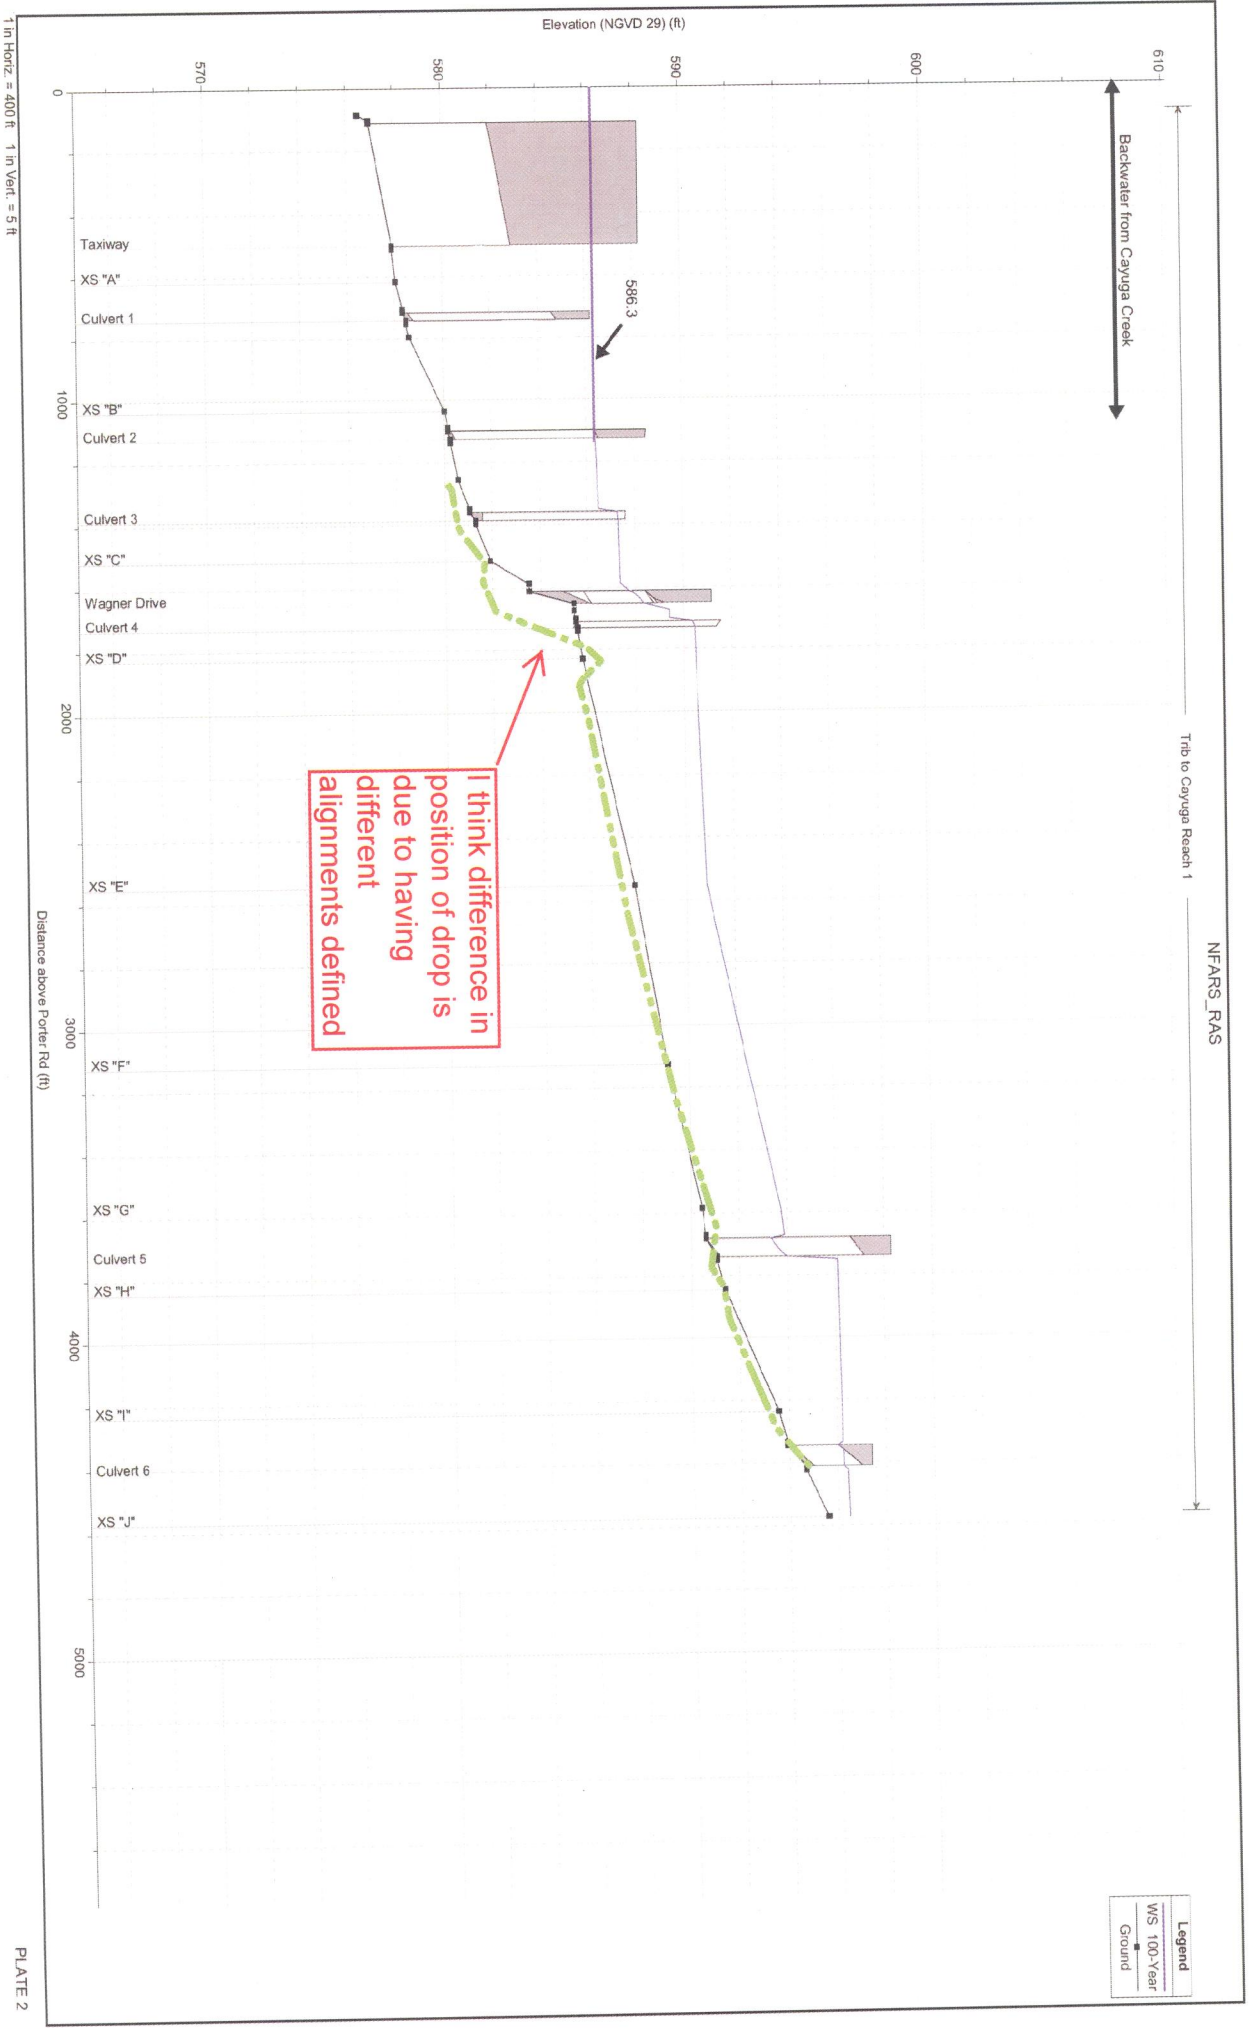
I think difference in position of drop is due to having different alignments defined

2005 SURVEY
2013 SURVEY

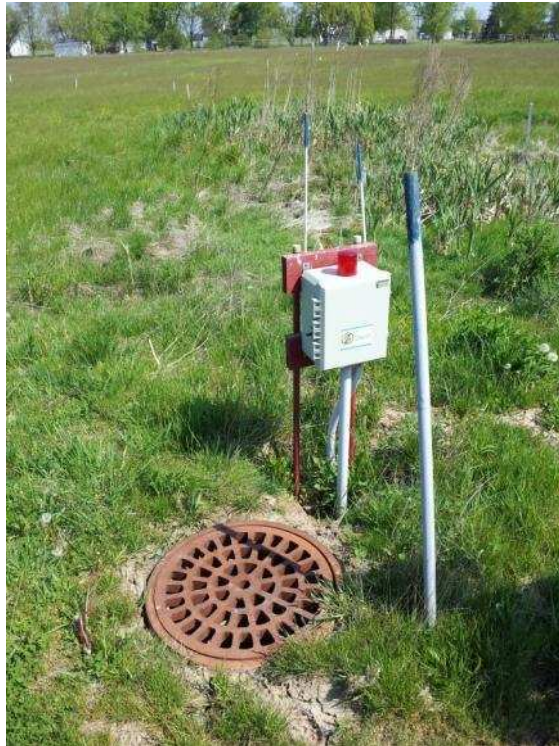
Description:
Lift station in the
southern boundary of
Area 1

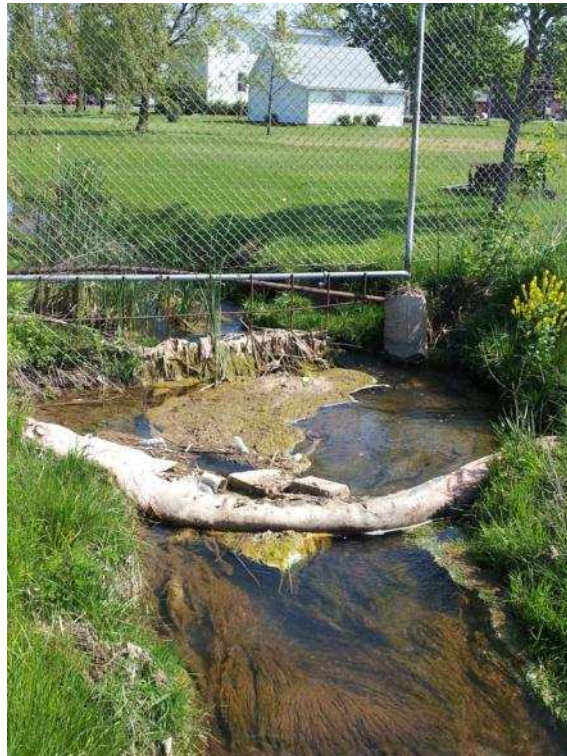
Description:
Unnamed stream flowing onto Area 1 along the northern boundary

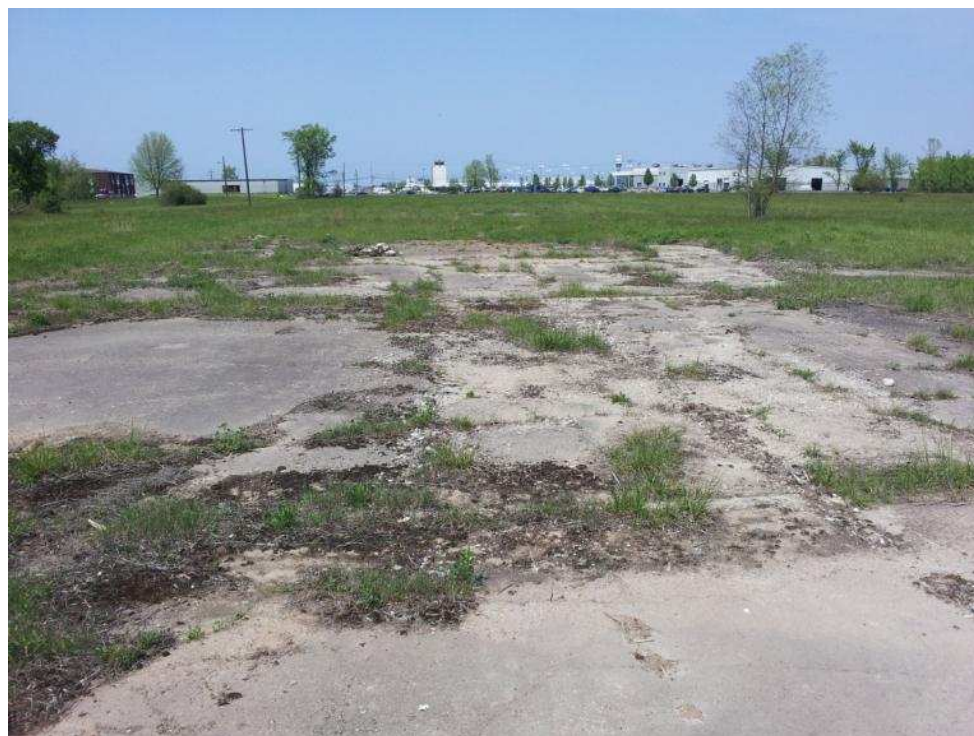
Description:
Concrete pads from former structures once located on Area 2

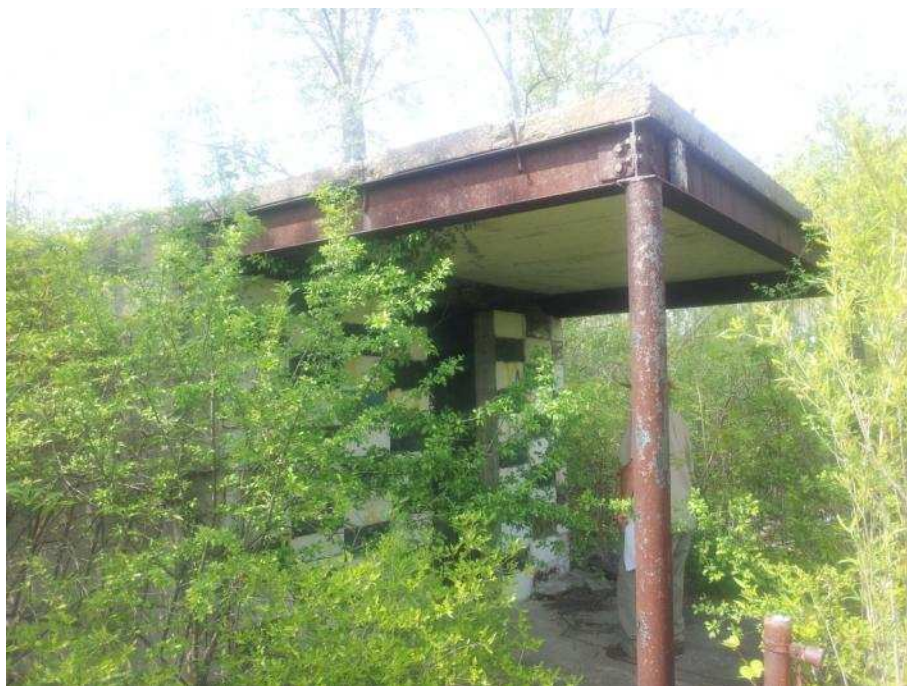
Description:
One of the two small race track structures that were observed on Area 3 during the VSI

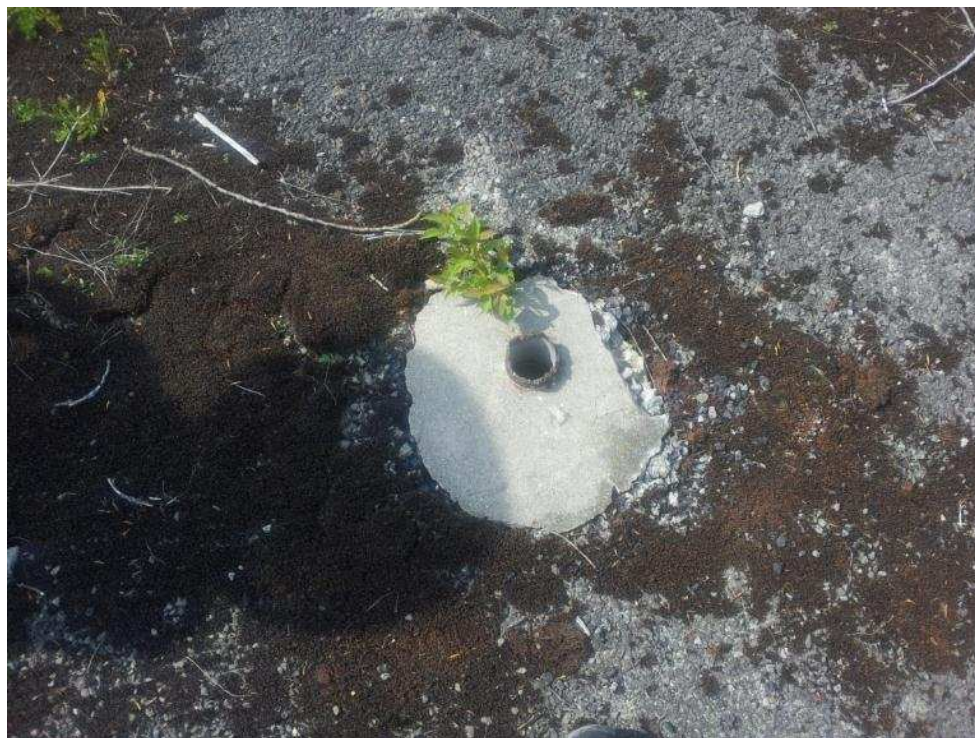
Description:
An old metal chain link fence pole in concrete that had been cut at the bottom
